BONUS Sunken Wreck Environmental Risk Assessment - Combined Modern Risk Tool with Oil Removal Assessment

WRECKS OF THE WORLD III: Shipwreck Risk Assessment

October 12-13 2015, Gothenburg, Sweden

Jorma Rytönen, Finnish Environment Institute

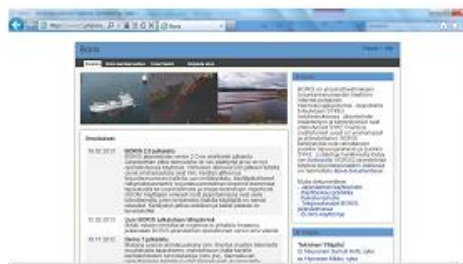
Figure 2. BORIS start page.

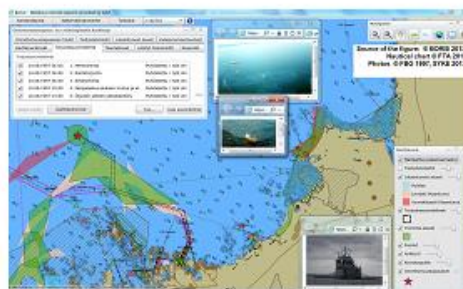
Figure 4. Reconstruction of the oil spill response operation after the grounding of m/s Hälsingland in Bay of Bothnia 1997. Observed oil spills are illustrated with red polygons and response areas with green polygons. Source of the figure: © SYKE/BORIS 2013, Nautical chart © FTA 2013, Photos © FBG 1997 and SYKE 2012.

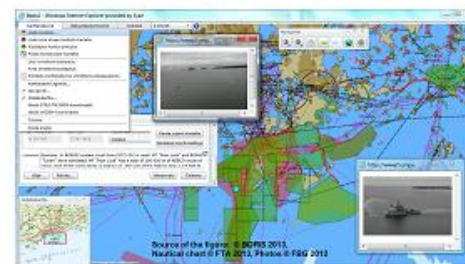
Figure 5. Oil spill scenarios (red polygons) and oil response areas (green polygons) of HELCOM fleet and Finnish Rescue Services Districts during HELCOM BALEX DELTA2012 Exercise in Gulf of Finland. Source of the figure: © SYKE/BORIS 2013, Nautical chart © FTA 2013, Photos © FBG 2013.

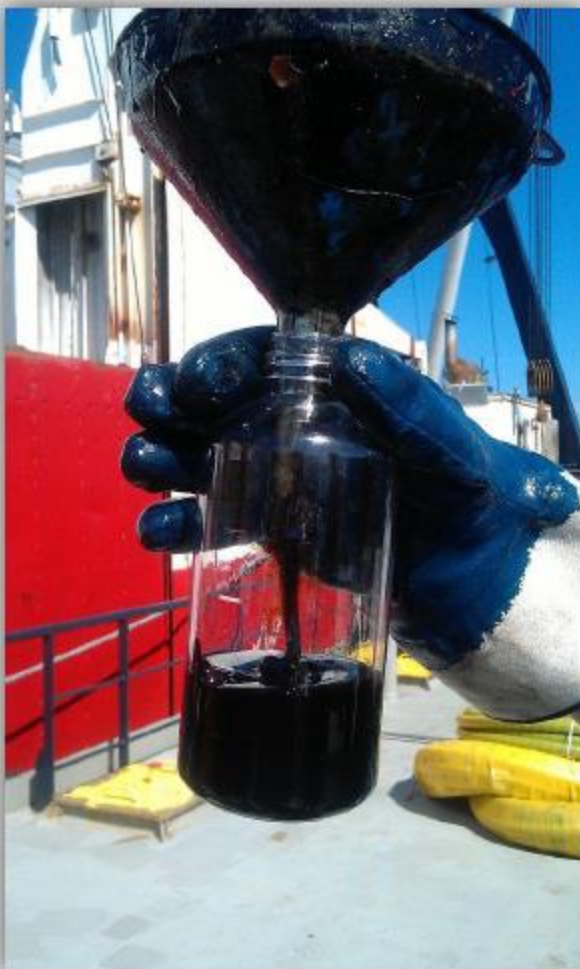
THE RESULT

Dirty water recovered 620 m³

Oil recovered 251 m³ = 249 ts.

Missing
335 tonnes

Operation lasted 50 days

The emptying of the FU SHAN HAI
24th of July - 12th of September 2013

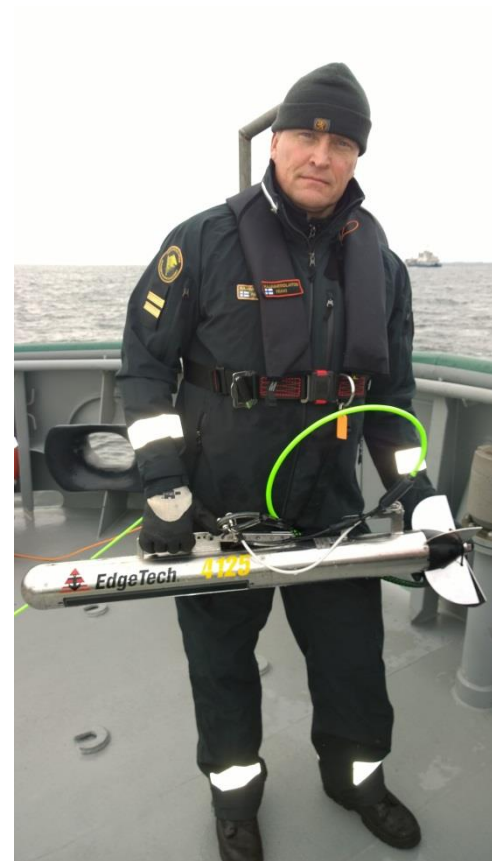
Side scan sonar tool used in Oxellösund by the Finnish Fronted Guard
